# Manhole Inspection Summary

Manhole # S19A\_\_006MH

Insp Date: **10/24/07 10:06 AM**

**Location** Address: **2104 LANVALE ST**

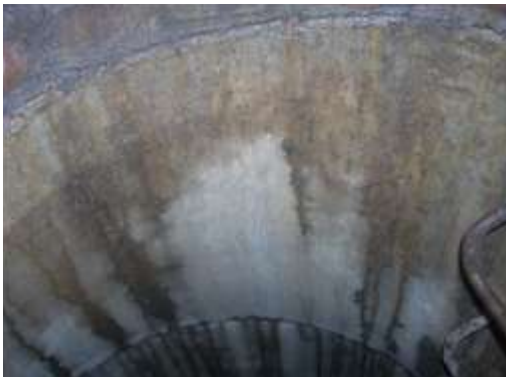
Defect 4

Infiltration: ☐ None ☒ **Joint** ☐ Cracks ☐ Mortar ☐ Roots ☐ Wall

INFILTRATION OF CORBEL AND  
BARREL JOINTS

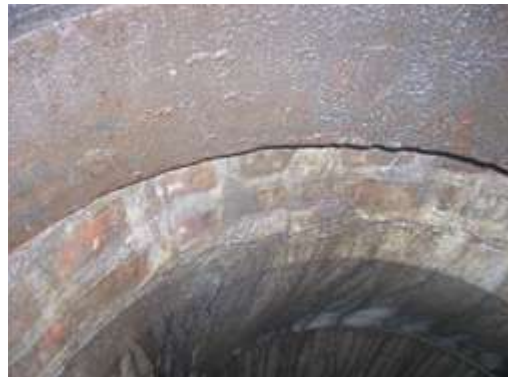
Defect 3

Condition: ☐ Sound ☐ Cracked ☐ Root Intrusion ☐ Loose Brick ☒ **Deteriorated**

DETERIORATED CHIMNEY

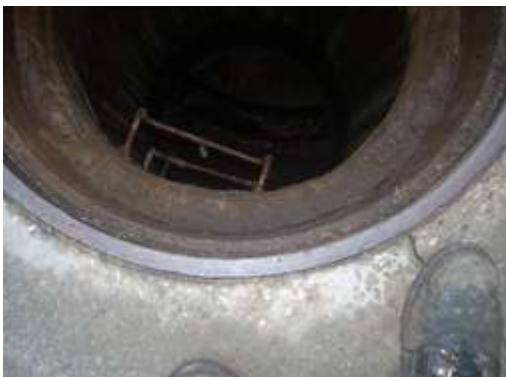
Defect 2

**Frame** Offset: **2** (in.) Condition: ☒ Sound ☐ Cracked ☐ Leaks

FRAME OFFSET

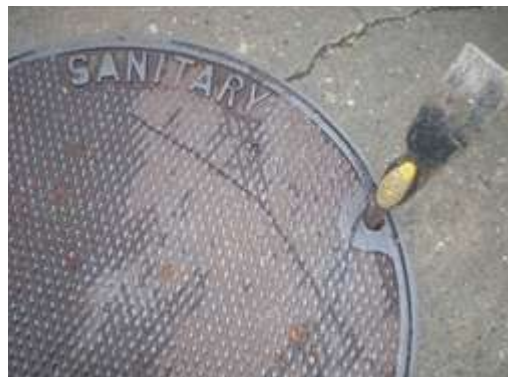
Defect 1

Type: **Sanitary** Condition: **Cracked** Cover Material: **Cast Iron**

CRACKED LID

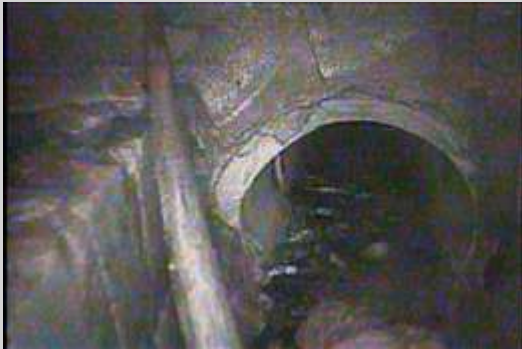
12 O'Clock Outflow

Pipe Height: **7.2** (in.) Rod and Bar (Angled)  
Pipe Material: **Clay** ☐ Pipe Lined  
Invert Depth: **11.40** (ft.) Flow Characteristics: **Slow**  
Deposits: ☐ None ☐ Mud ☐ Sludge ☒ **Debris** ☐ Grease  
Silt Depth: **1** (in.) Deposits Extent: **Light**  
Infiltration: **None** Pipe Seal Cond: **Cracked**

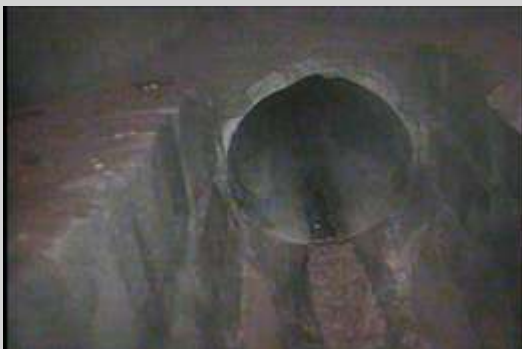
5 O'Clock Inflow

Pipe Height: **7.2** (in.) Rod and Bar (Angled)  
Pipe Material: **Clay** ☐ Pipe Lined  
Invert Depth: **11.27** (ft.) Flow Characteristics: **Slow**  
Deposits: ☒ **None** ☐ Mud ☐ Sludge ☐ Debris ☐ Grease  
Silt Depth: (in.) Deposits Extent:  
Infiltration: **None** Pipe Seal Cond: **Sound**
